Manhole Inspection Summary

Manhole # S39CC1002MH

Insp Date: **12/12/06 10:23 AM**

Location Address: **760 MCKEWIN AVE**

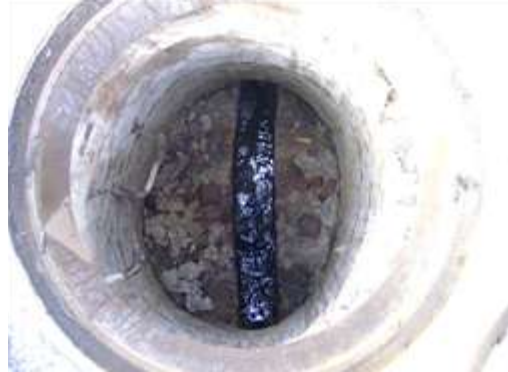
Top View

Corroded and missing steps. Evidence of surcharge - Bench debris. Channel debris.

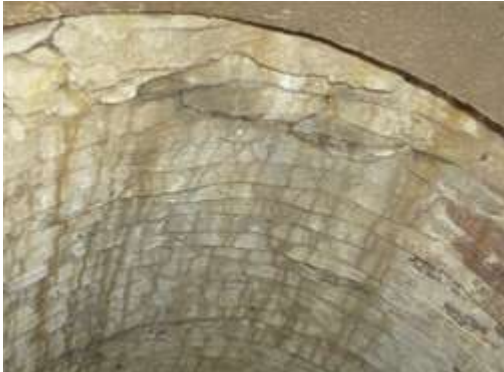
Defect

Frame leaks. Adjustment infiltration.

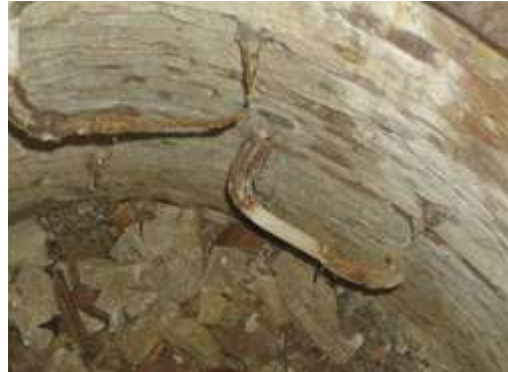
Defect

Corroded and missing steps.

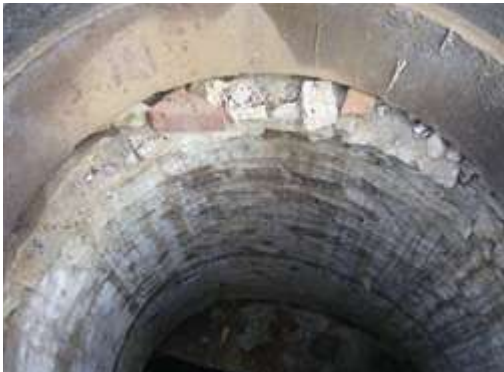
Defect

Frame leaks. Frame offset. Adjustment deterioration, loose brick and infiltration. Barrel infiltration.

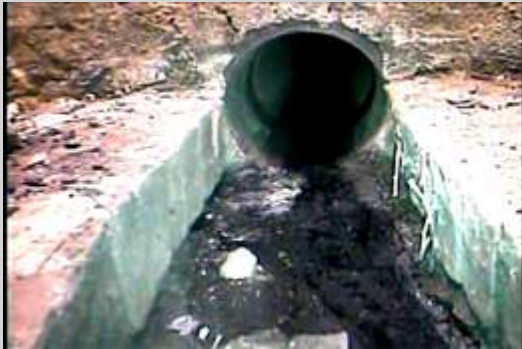
8 in. Circular Gravity Sewer Pipe Out @ 12 O'Clock

Deposits: ☐ None ☒ **Mud** ☐ Sludge ☒ **Debris** ☐ Grease

Silt Depth: **0.5** (in.) Deposits Extent: **Light**

Infiltration: **Evidence** Pipe Seal Cond: **Unknown**
